Oil Spill Response Log for the Indian Point Unit 2 #21 Main Transformer Oil Spill

The following is a chronological record of the activities performed at the Indian Point Energy Center in response to the transformer oil spill of 11/7/10. Note that where given product recovery volumes are estimates and are not yet final since the receiving frac tanks are still in service and have not fully settled.

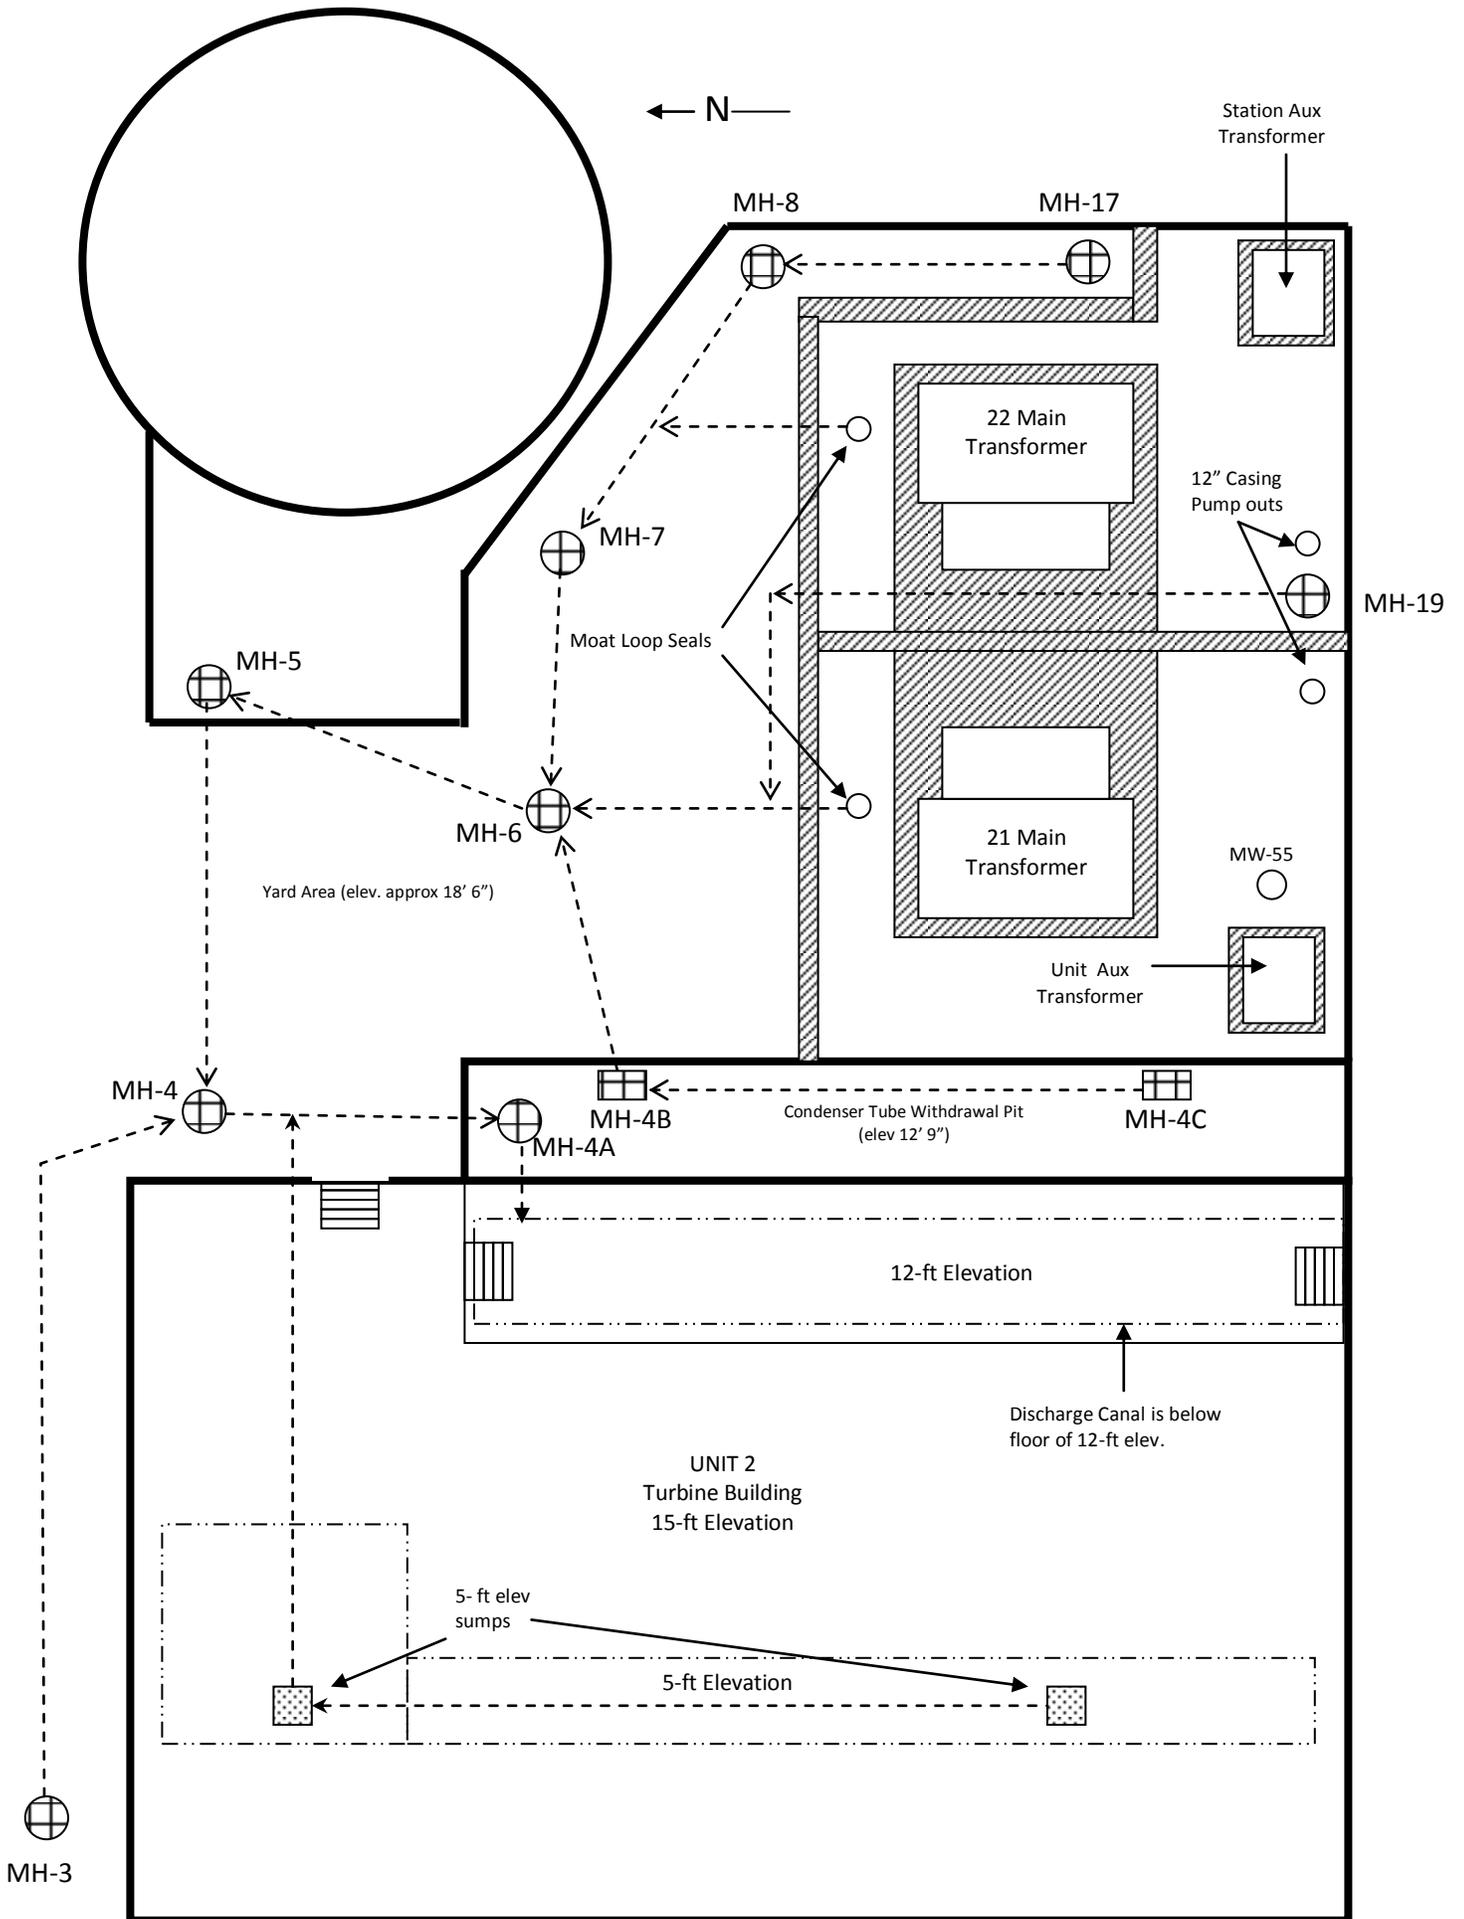
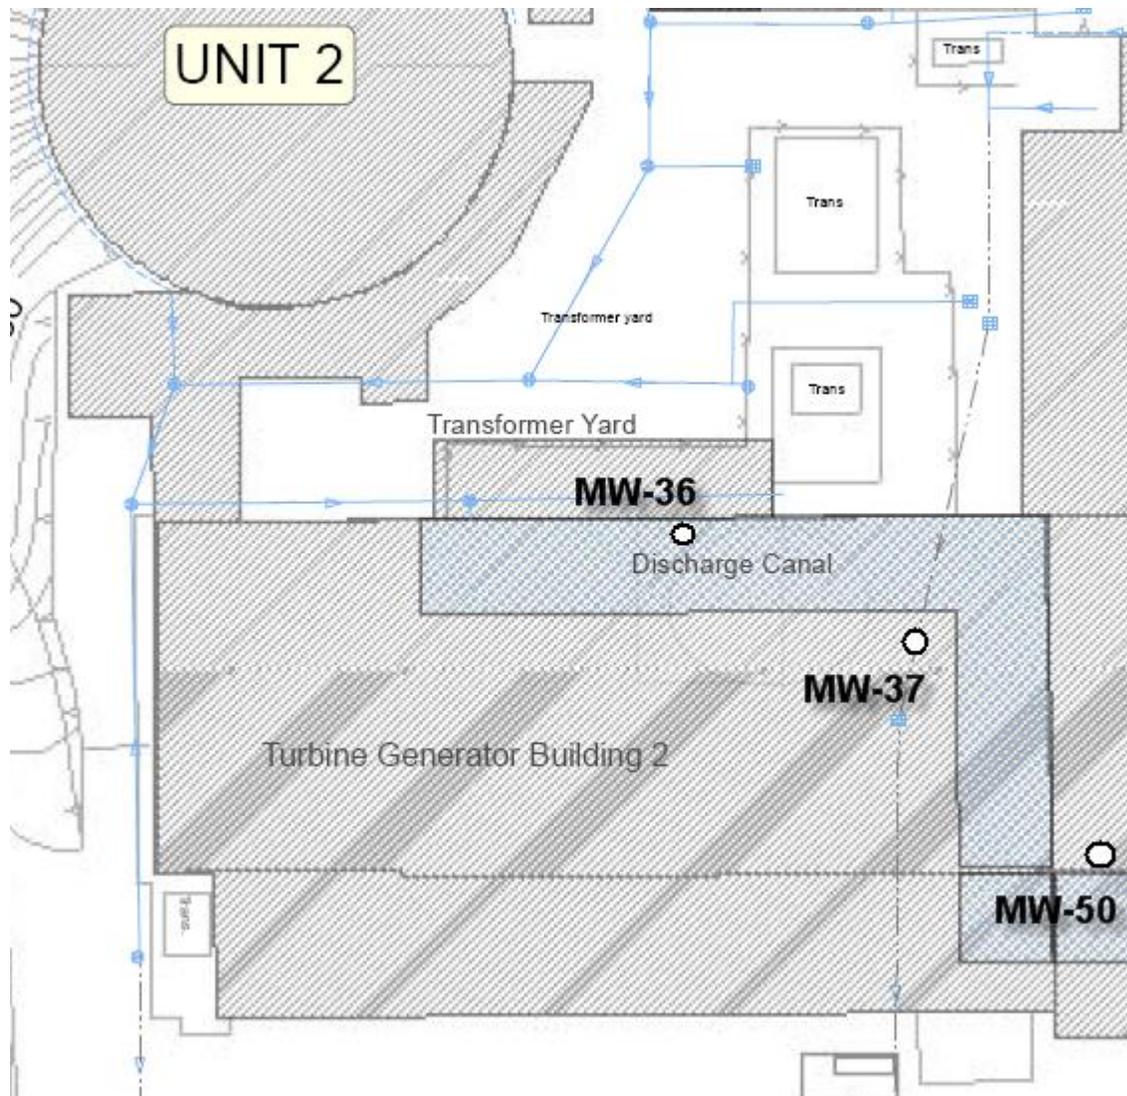
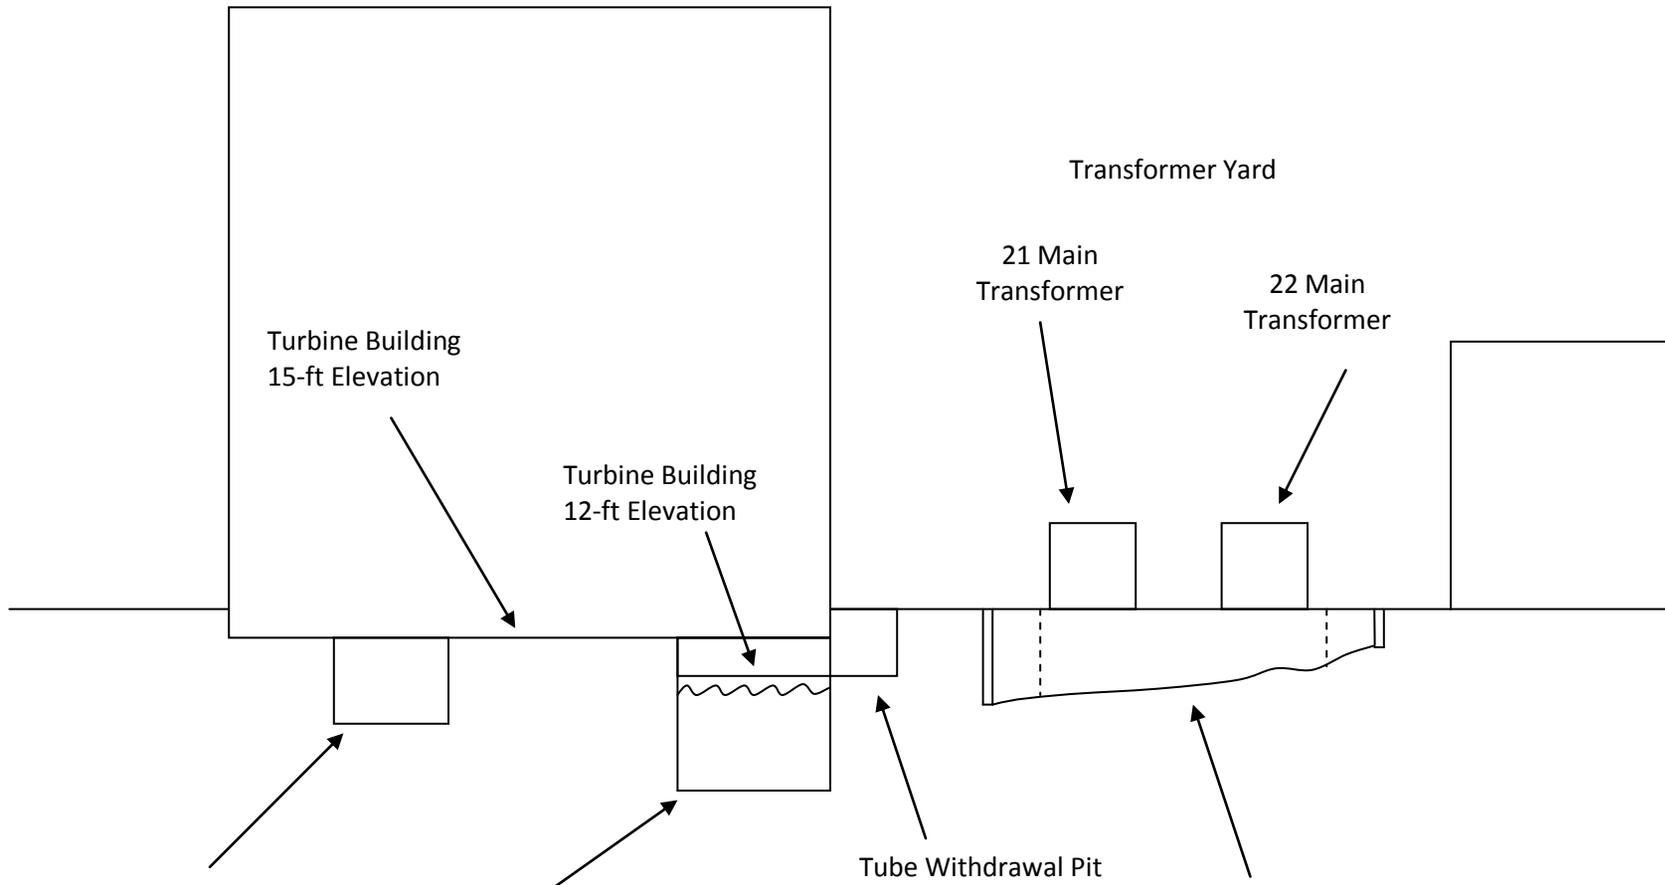
5-ft elevation

Discharge Canal

Tube Withdrawal Pit

Moat:
 Poured concrete walls down
 to bedrock and backfilled with
 blue stone. Transformers
 reside on concrete pads
 poured to bedrock.
